StreetSafety

Issue No. 3
2010

Six Crosswalk Systems Improve Safety at University of North Florida

Six in-pavement lighting systems were installed at major student crossings on campus. In addition, speed humps and raised tables were included as part of a scheduled repaving project. These improvements helped reduce speeds and increase pedestrian safety.

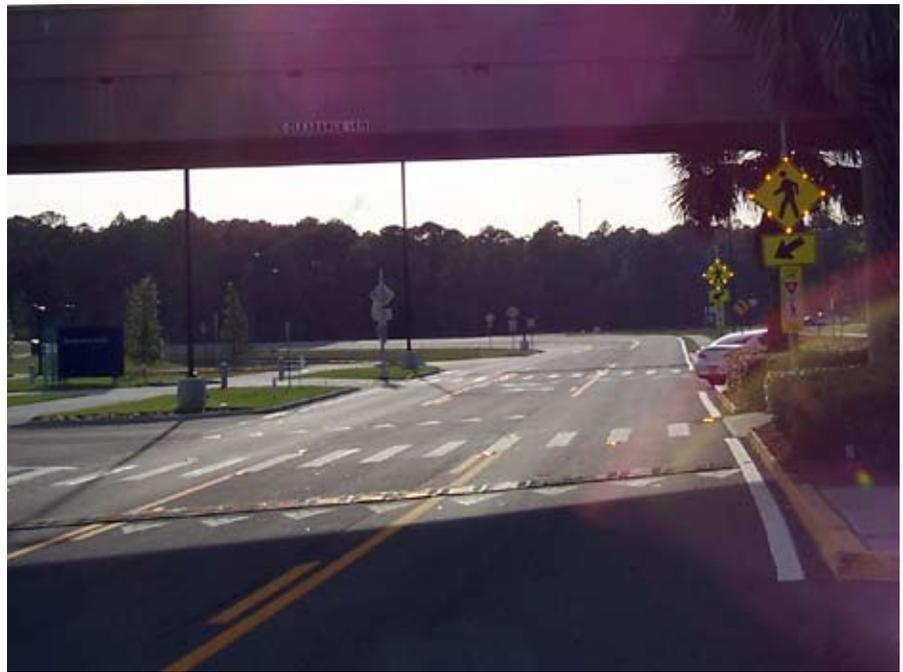
Speed humps, flashing signs, and in-pavement lighting on UNF Drive.

walk systems, “Our crosswalk warning light systems are very reliable and designed to flash continuously. The warning they provide to drivers while they approach the crossings is undeniable. Drivers are slowing down. There’s a quantifiable change in their behavior. The warning light systems and the raised roadway [speed humps and raised tables] have cut driver speed in half, from 30 mph to about 15 mph.”
