In-Pavement Flashing Crosswalks - State of the Art

Article by Rock Miller, PE, PTOE and George Dore, PE, Katz, Okitsu & Associates

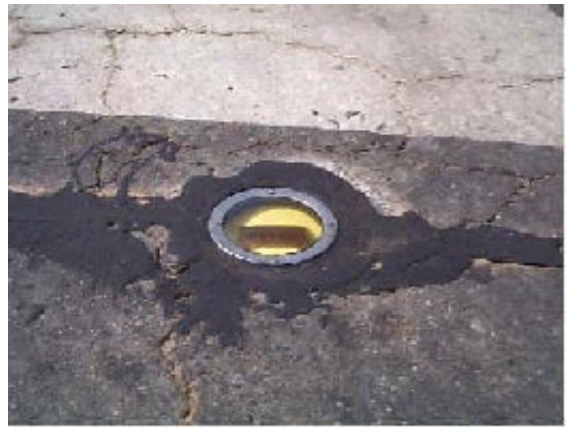
The past four years have seen the development and perfection of a new treatment for uncontrolled marked crosswalks. The device is known by many terms, including "Illuminated Crosswalk;" however, the most commonly known device of this type is generally referred to as an "in-pavement flasher system" (IPF). These devices are mounted in the street pavement adjacent to the outside of the crosswalk markings. They are normally dark, but they are actuated to provide a flashing yellow light while the pedestrian crossing is in use. The photo shows a typical IPF.

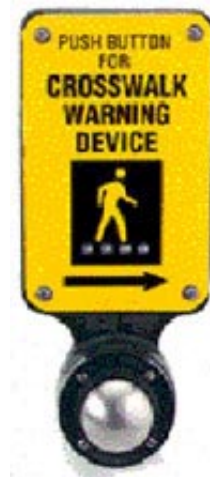
The following information was compiled for 100 locations where these devices are installed.

- Average daily traffic ranges from 2,500 to 23,100 vehicles per day.
- The number of lanes crossed ranges from 2 to 5 lanes.
- About 18% of the roadways have a median.
- About 65% of the roadways have a left-turn lane.
- About 71% of the sites allow parking on the street.
- About 24% of the roadway cross-sections have bike lanes.
- About 19% of the crossings are school crossings.
- About 59% of the installed in-pavement flashers are activated by push-button.
