StreetSafety

News

Issue No. 6
2009

Combined Lighting Makes Hospital Crosswalk Safer

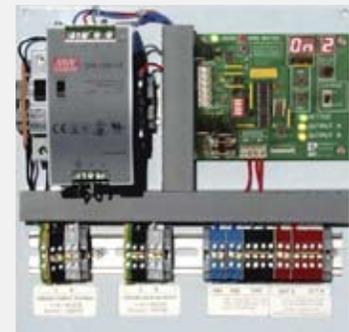
TS1000 Controller

The patent pending TS1000 is a next generation controller designed from the ground up for superior performance, easy installation and outstanding reliability. The TS1000 supports a wide range of crosswalk system configurations, and is compatible with standard activation devices (push-buttons, pedestrian crossing pads) and standard pre-warning devices (LED flashing signs and beacons).

Color coded terminal blocks reduce installation time.

This project was the first to use the new TS1000 controller. The device is designed to make drivers aware earlier with MUTCD-compliant (Manual on Uniform Traffic Control Devices) flash patterns. One of nine preset flash patterns may be used.

Or the system may be set to cycle through a different pattern on each activation. The TS1000 also controls how fixtures and advanced warning signs display flash patterns. Equipment may flash the same pattern, or different patterns, simultaneously or alternately (wig-wag).

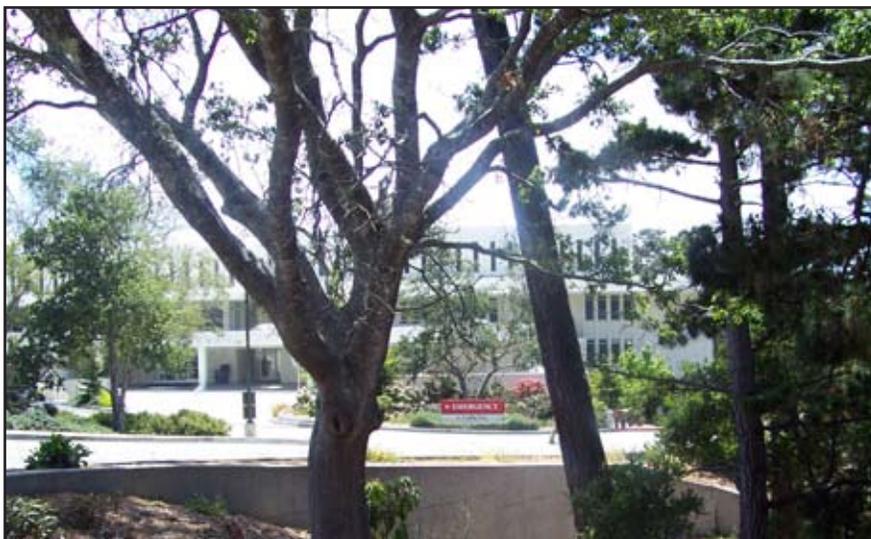
The employee parking area is separated from the hospital by a winding road.

Patients and employees were at risk using a crosswalk on a blind curve at the Community Hospital of the Monterey Peninsula. Hospital administrators began looking at safety equipment to prevent accidents.

The Community Hospital of the Monterey Peninsula recognized the danger at a commonly used crosswalk on a blind curve. Lauren Elsensohn, Media Specialist with the Community Hospital of the Monterey Peninsula, describes the situation, "The hospital felt they had to do something to address the issue of pedestrian safety. The problem was that drivers couldn't see the crosswalk or pedestrians until they completed the turn, just prior to reaching the crosswalk. By that time it would be too
